**Historic District Commission
Staff Report: RETROACTIVE Certificate of Approval
HDC2013-00608, 200 W. Jefferson Street**

APPLICATION DESCRIPTION: Retroactive Certificate of Approval for porch enclosure modifications

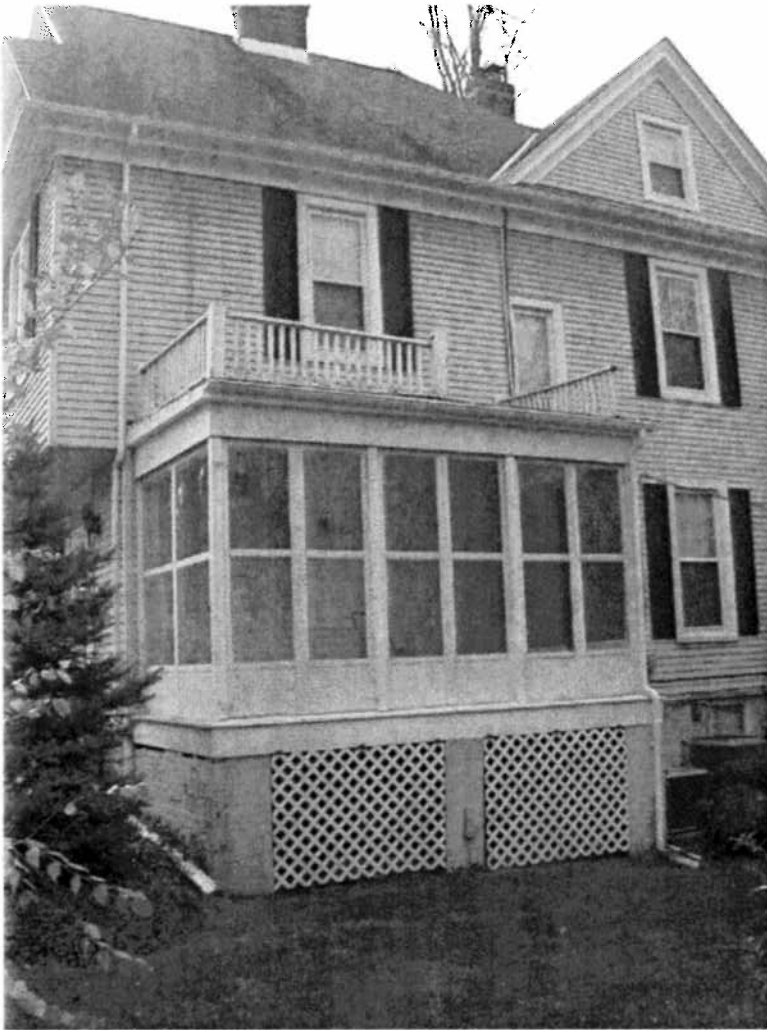
2004 Photograph of porch enclosure. The then-owners requested HDC approval to remove the top railing, and this was approved.

Key Features include the four columns across this north elevation, with thinner vertical mullions separating paired groupings of window inserts.

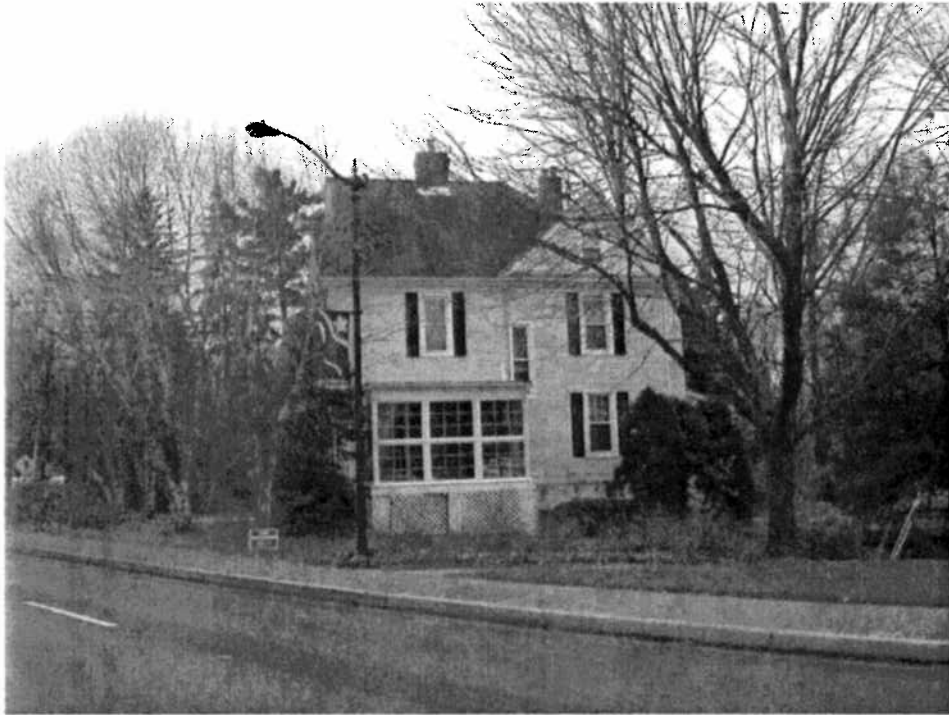
North (side) elevation (2012)

Existing Conditions: The side porch has been permanently enclosed with large thermally-glazed windows with two distinct configurations. The north elevation has three bays with six panels. Both the east and west elevations have one bay with three large horizontal panels. The central panel on both elevations consists of glass and screen segments to provide an opportunity for fresh air ventilation. The new window segments have grill inserts between the glass to approximate the appearance of smaller panes of glass.

Staff Recommendation (Existing porch enclosure): The existing porch enclosure is incompatible with the historic resource because the installation is internally inconsistent in design, with the east and west elevations having a distinctly different design from the north elevation. In addition, the overall design emphasizes a horizontal orientation while the house is a typical Victorian design with a vertical orientation. Orientation is a character-defining element of architectural design, and Victorian resources emphasized the “vertical.” This stands in contrast to early 20th century architecture, such as the Prairie Style, where horizontality was key. While these concepts apply broadly, the historic resource at 200 West Jefferson illustrates a vertical orientation, with steep ridge lines and narrow/tall windows.

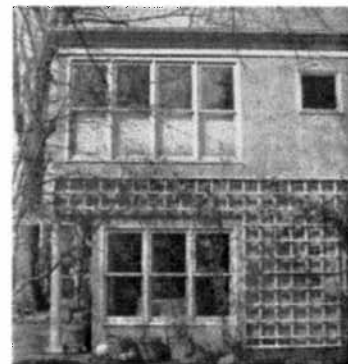
The National Park Service discusses the character-defining elements of a porch, such as porch columns (see Attachment 8). Staff notes that the current enclosure retains the prior porch column spacing, but

seems to lack columnar definition by installing a horizontal mullion with the same “weight” as the vertical mullions/columns.

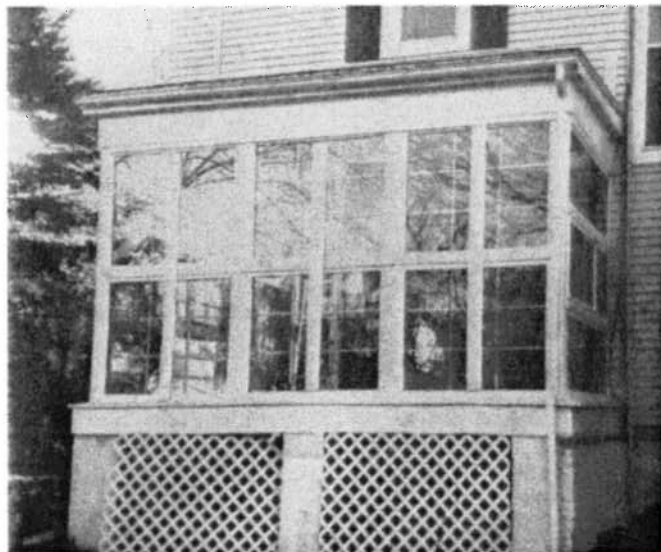
Proposed North Elevation

The owner proposes to add vertical mullions on the north elevation between each of the existing column/vertical elements. The new vertical mullions would be installed on the exterior of the glass, and would be notably narrower than the column verticals to retain emphasis on the columns. On the shorter east and west elevations, the owner proposes to reinstall the three horizontal units as vertical units, or a configuration as illustrated that would achieve the same result.

Staff finds this proposal to be acceptable in that it would change the proportions of these porch openings to the more narrow, vertical orientation that is compatible with the Victorian resource. Staff recommends that the HDC approve this alternative, provided that additional details concerning materials, grill installation and dimensions such as the mullion width are confirmed at or prior to the meeting.

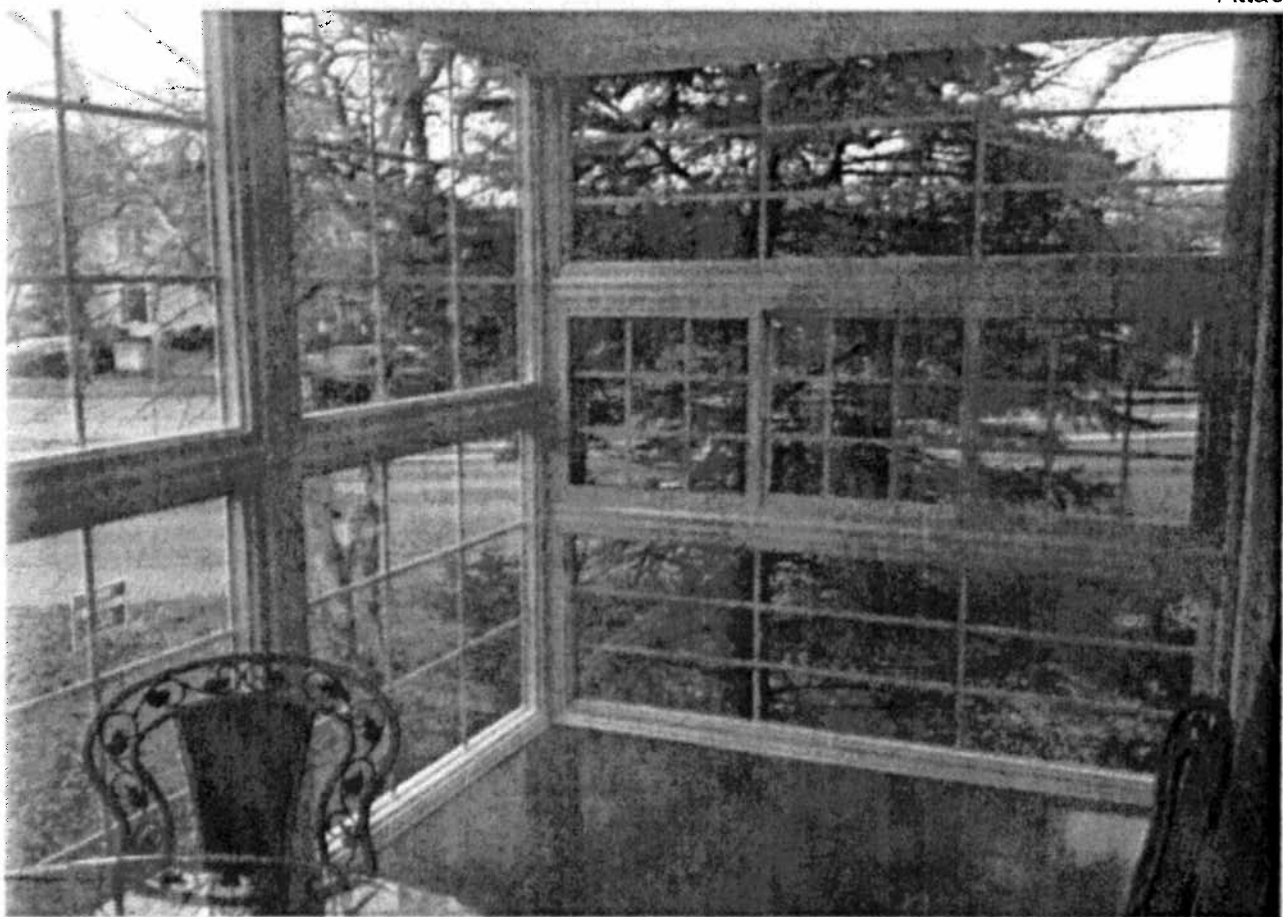
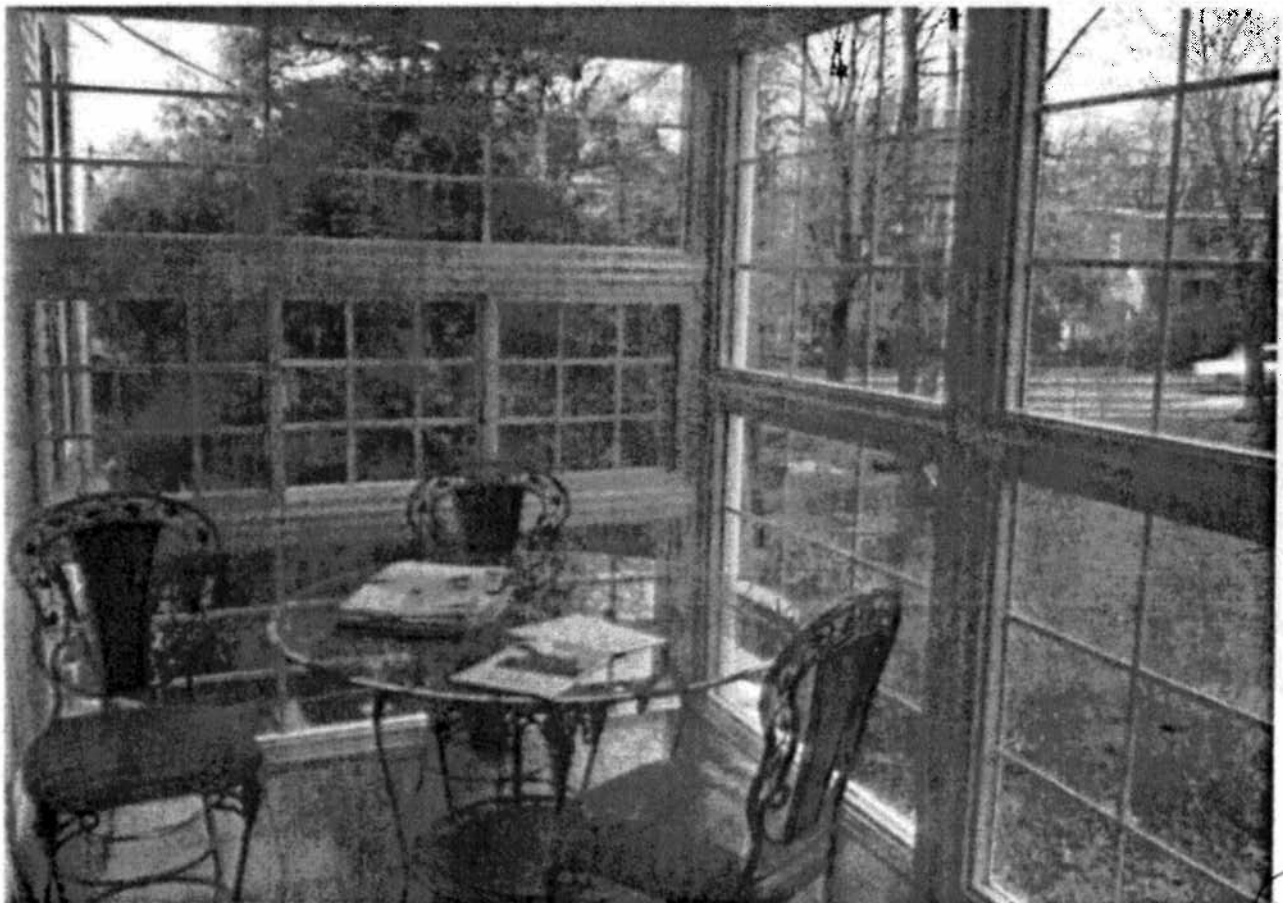
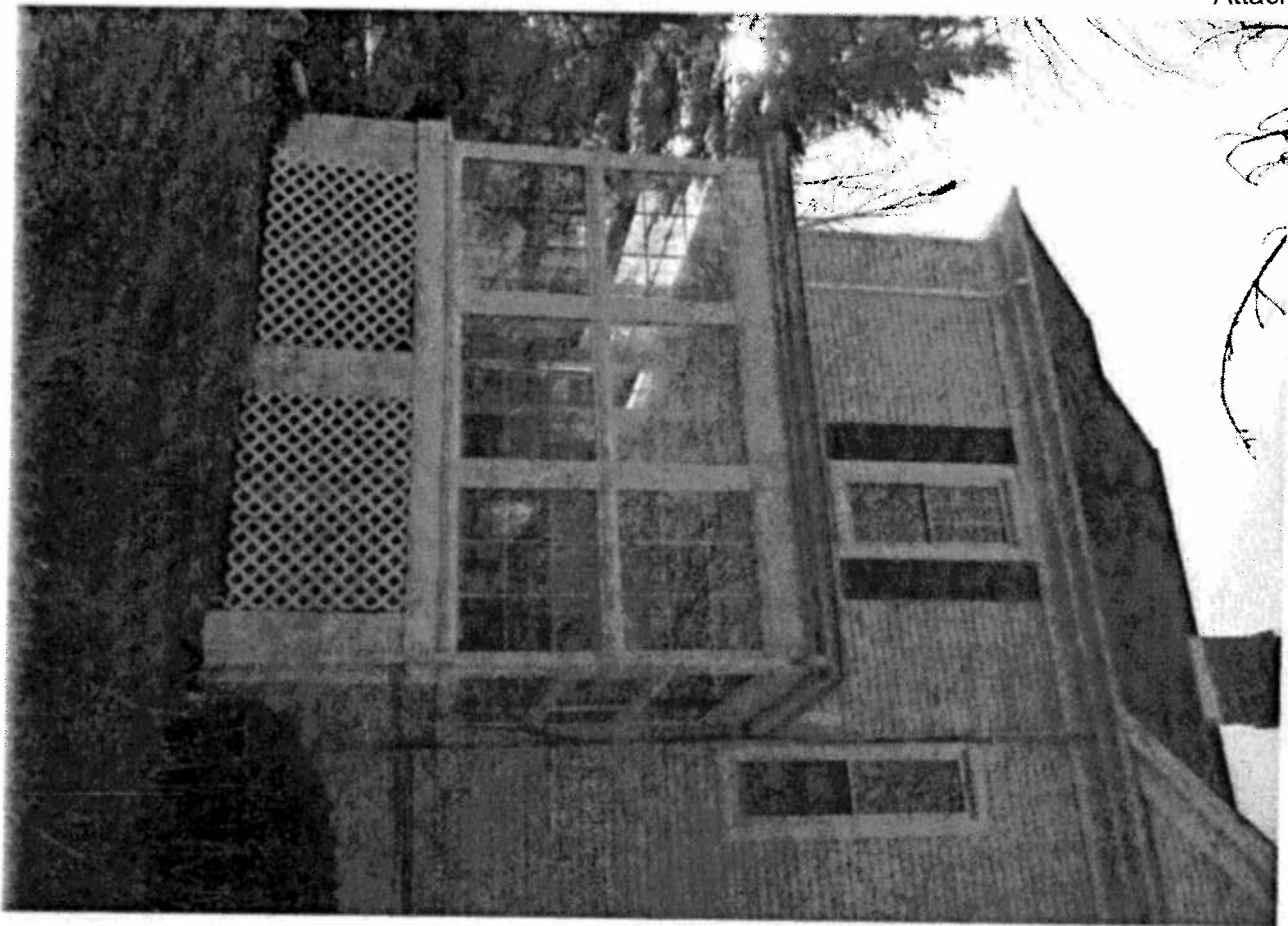
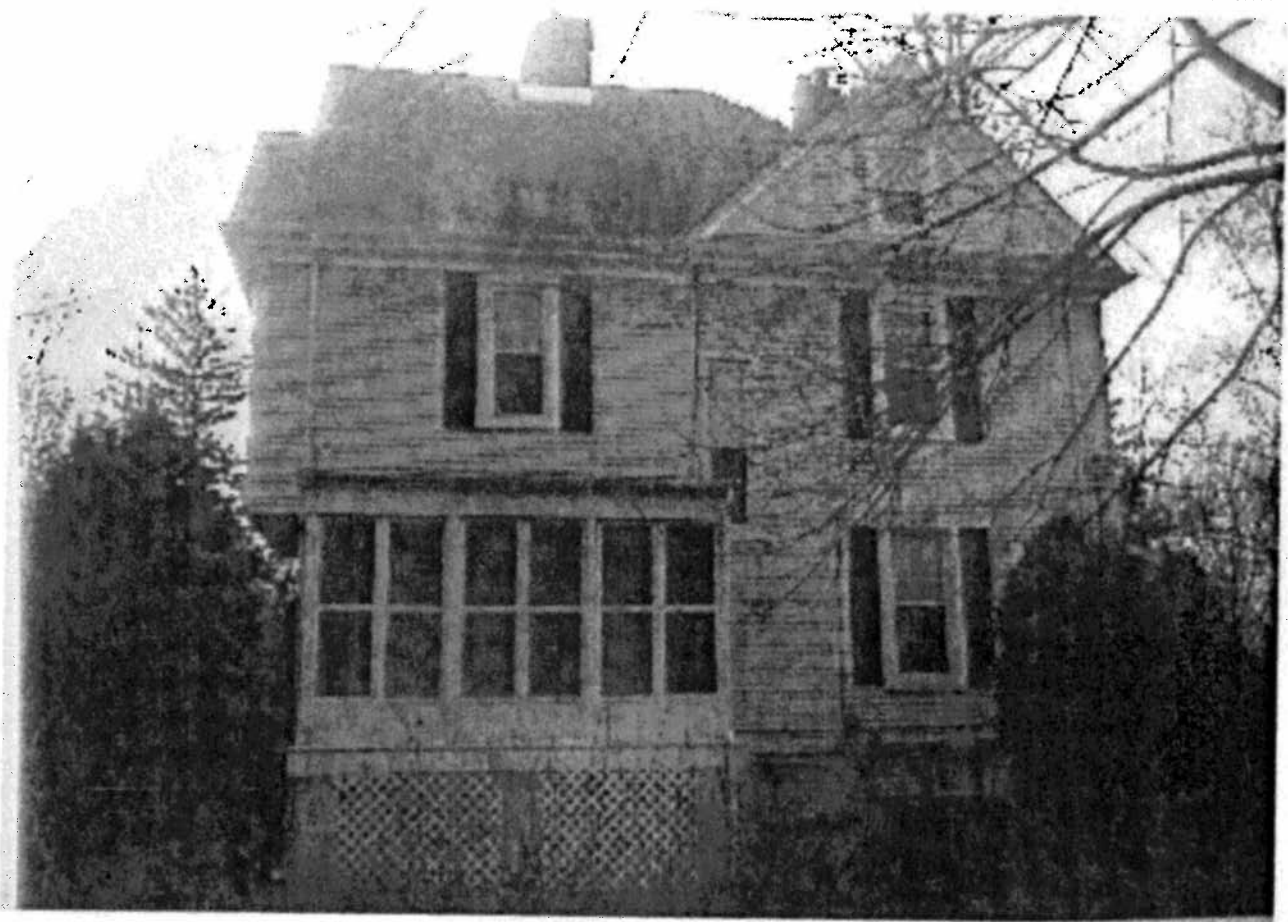
These efforts, using paper and scissors, provide a notion of what the side might look like if we removed and rotated the windows from horizontal to vertical. The reflections in the glass distort the appearance. The sliders would have to be replaced; only four of the six windows might be re-used in this manner. The side is not a perfect square, but close enough that such a solution can be contemplated. It would be a lot of work.
Tom

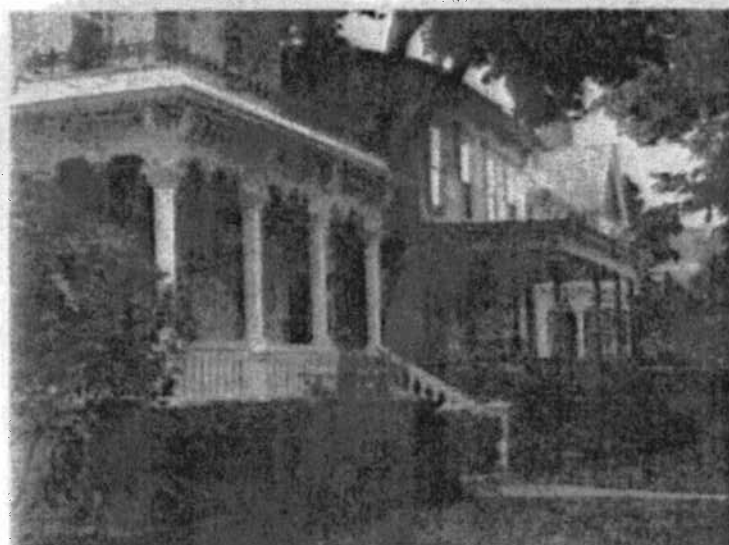
Figure 1. Distinctive yet different, these front porches are important features along the street. The rhythm would be diminished if the front porch from one of the houses was dramatically altered or removed. Photo: Aleca Sullivan.

Few architectural features evoke more romantic notions or do more to define a building's historic character than the American porch. The size, style, detailing, and location of a porch can tell volumes about the age and use of a building. Each component, from handrail or baluster to column or post, enhances the architectural character of the porch. Alter or remove the porch and a historic building or streetscape can lose its visual integrity and historic authenticity (Fig 1).

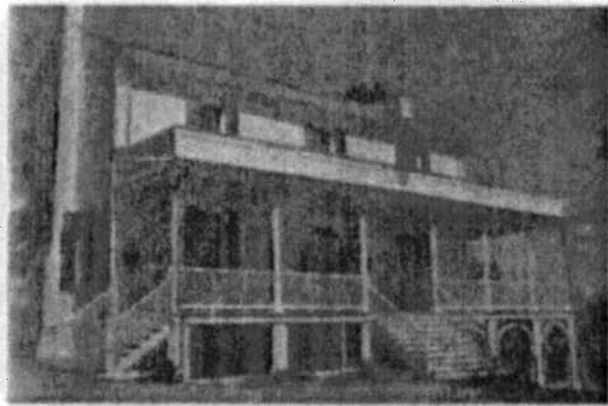
Figure 2. Porches not only help define the architectural character of a building but also serve as living areas. They can be designed to take advantage of surrounding views. Cedar Grove, the home of the nineteenth-century landscape painter Thomas Cole, has an L-shaped veranda on the front and a two-story porch on the rear, providing an enviable view of the Catskill Mountains. Photo: Marilyn Kuplan.

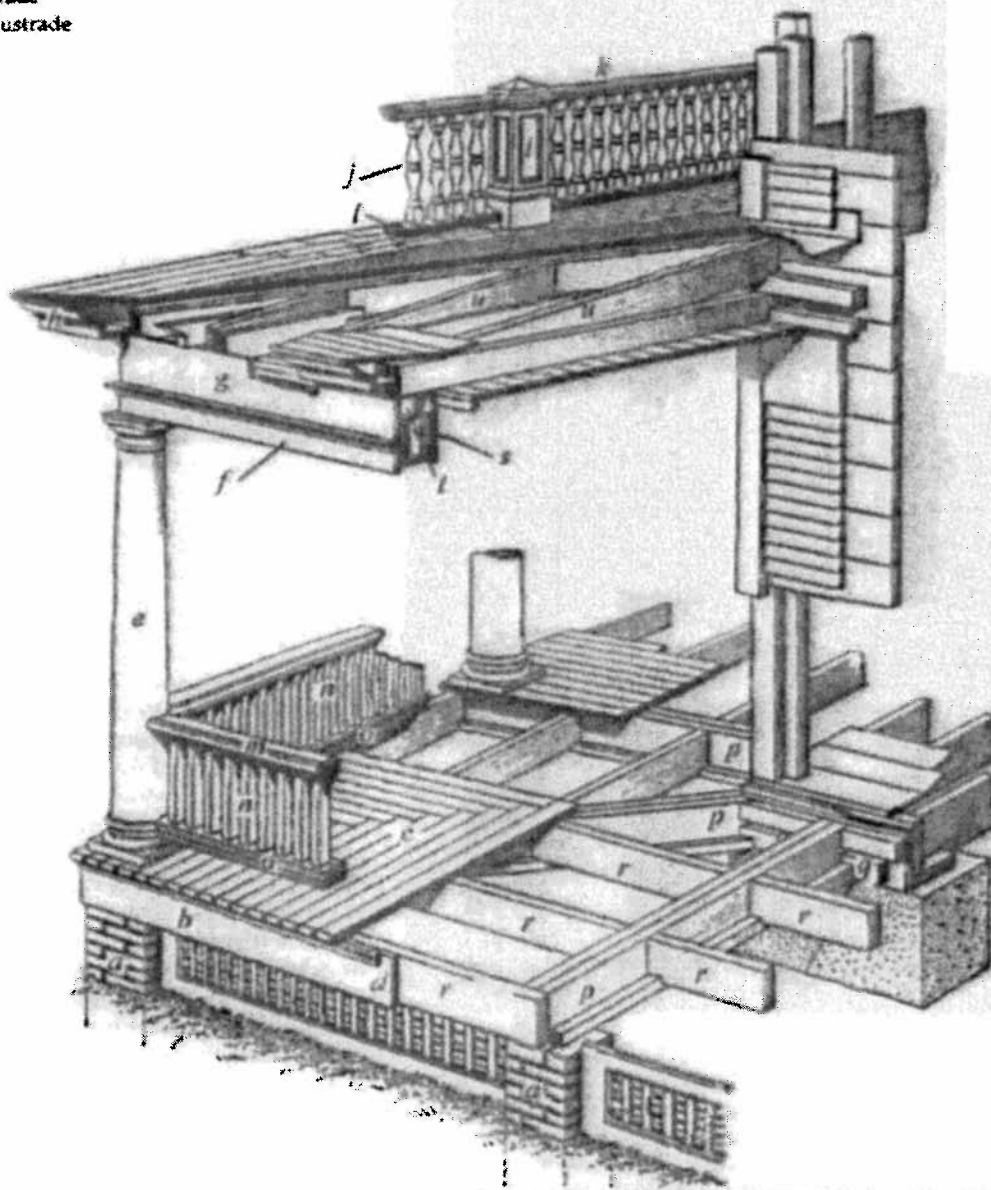
Drawing courtesy of Thomson Education Direct.

- s - Beams inside the entablature span from column to column, support plate
- t - Plate of the entablature rests on beams, supports roof rafters and ceiling beams
- u - Rafter of the roof structural system

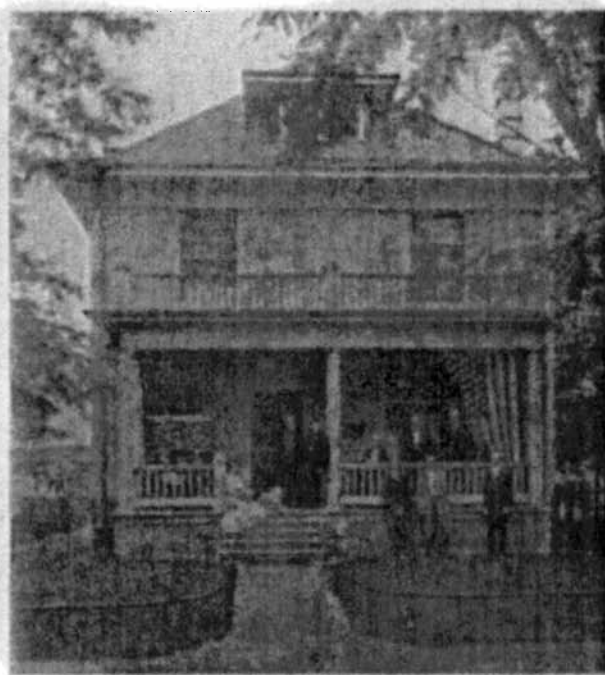
Figure 4. Celebrating the 4th of July in 1912, this gathering of family and friends reflects the popularity of the porch as a social gathering place. While not overly ornate, each detail of the porch from the roof balustrade to the turned columns to the simple lattice work facing the deck contributes to its character, creating in effect the dominant architectural feature of the building. Photo © Utah State Historical Society

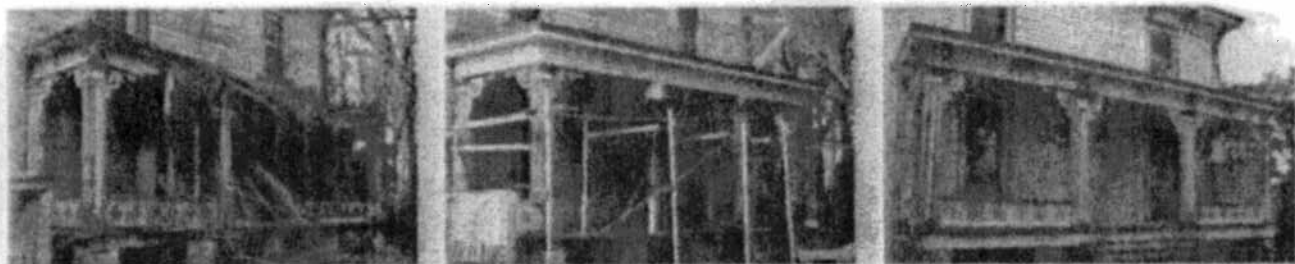
Figure 5. Even historic porches that appear to be in total disrepair may be repairable. While the roof needed replacement, much of this porch was repaired, including such features as the decorative columns, ornamental brackets, and balustrade. Photos: John Locke.

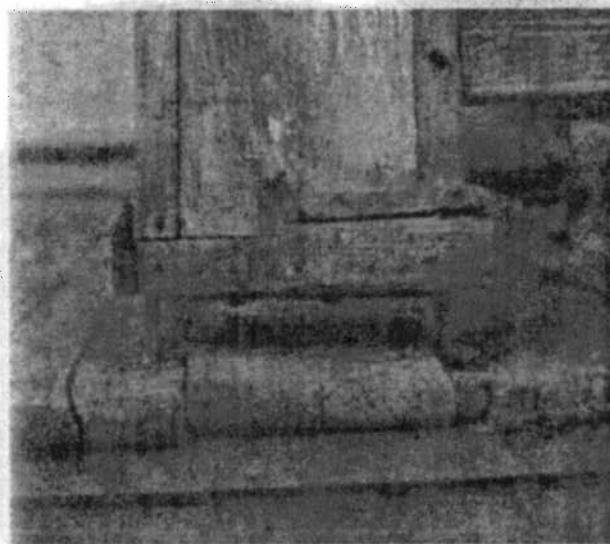
Figure 6. A traditional way to extend the life of porch posts was to place posts on metal feet, thereby providing a separation between the wood post and wood deck. This helped to prevent the wood post from rotting at the base. Early post feet were simple iron bars bent into a stirrup shape. By the late nineteenth century manufactured cast-iron feet were common, consisting of a pair of disks separated by a short pipe. Post feet are still available today. Courtesy of Old-House Journalist Brian McNeil.

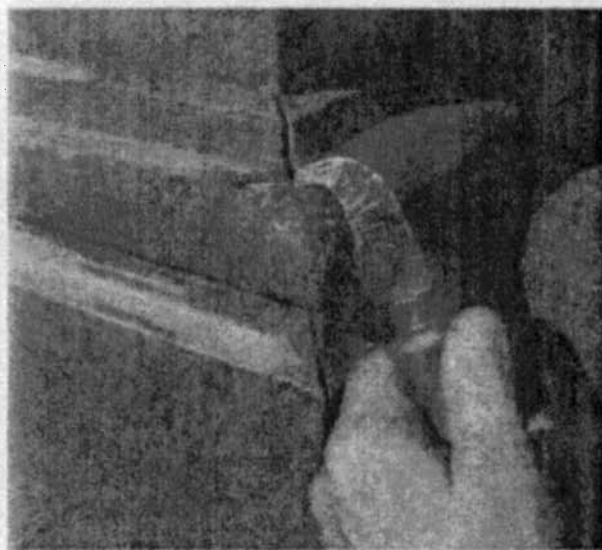
Figure 7. Common problems with porches that can contribute to serious wood decay include cracks in woodwork and joints that have opened up. Both provide an easy path for water seepage. Trapped moisture can foster peeling paint, wood decay and insect infestation. Open joints and cracks should be checked for evidence of more serious decay and marked for caulking or repair. Photo: John Locke.

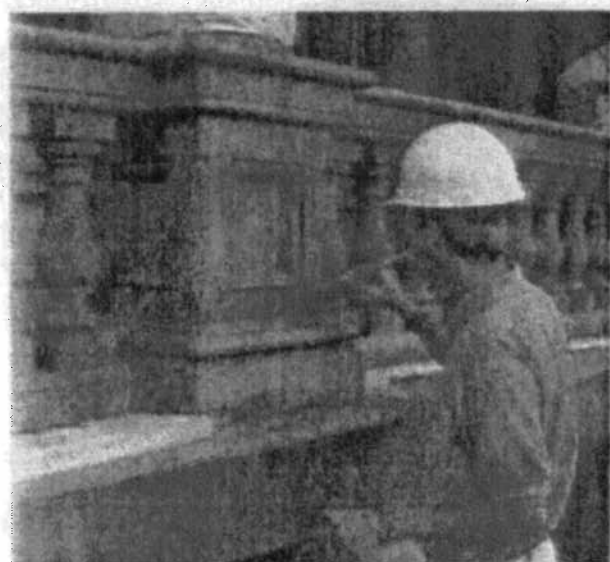
Figure 8. Decay can start when wood is left exposed to the weather or where joints open up. An inexpensive way to extend the life of the existing porch paint without jeopardizing the historic material is spot paint and caulk where needed every year or two. This cost-effective procedure is particularly effective in maintaining wood porches where the exposure to weathering is high. Photo: John Lirke.

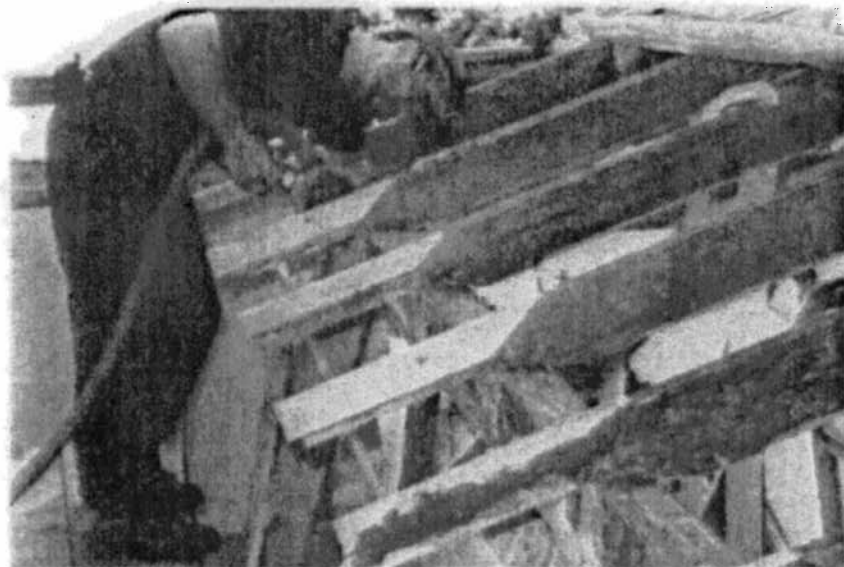
Figure 9. The ends of porch roof rafters are often susceptible to moisture decay. When concealed by a soffit or ceiling, rafters can be repaired by adding new sister boards. Where roof rafter ends are exposed, splicing new wood onto the old (*dutchman* repair) and use of epoxy consolidants and fillers both preserve sound historic fabric while retaining the historic appearance.

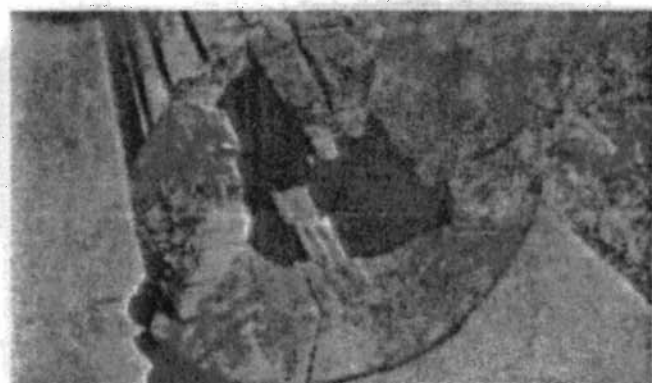
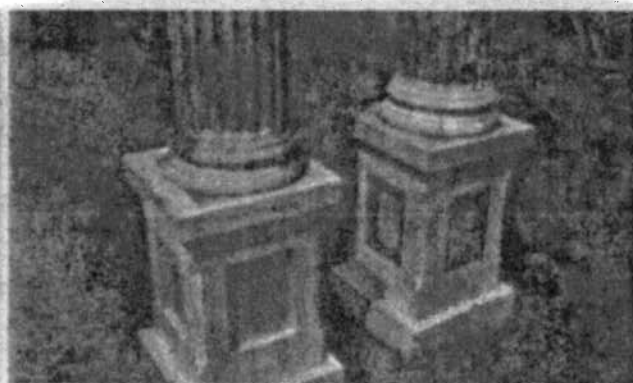
Figure 10. This nineteenth century porch column is made of wood staves, similar to the way a wood barrel is put together. After replacing the hirus and making dutchman repairs to the apophyge along the base, the column and pedestal are ready to be reinstalled on the porch. Photos: NPS files.

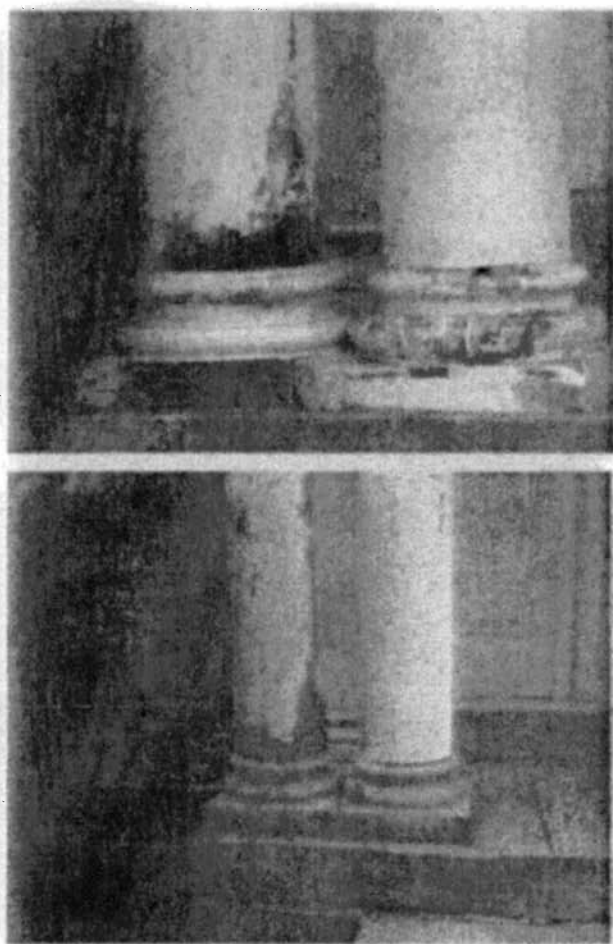
Figure 11. The lower shaft of the porch columns had decayed as water wicked up through the end grain (top). The column shafts were repaired in place by cutting out the deteriorated wood and making repairs using epoxy consolidants and fillers (bottom). The column bases were replaced. Photos: Paul Marlowe, Marlowe Restorations.

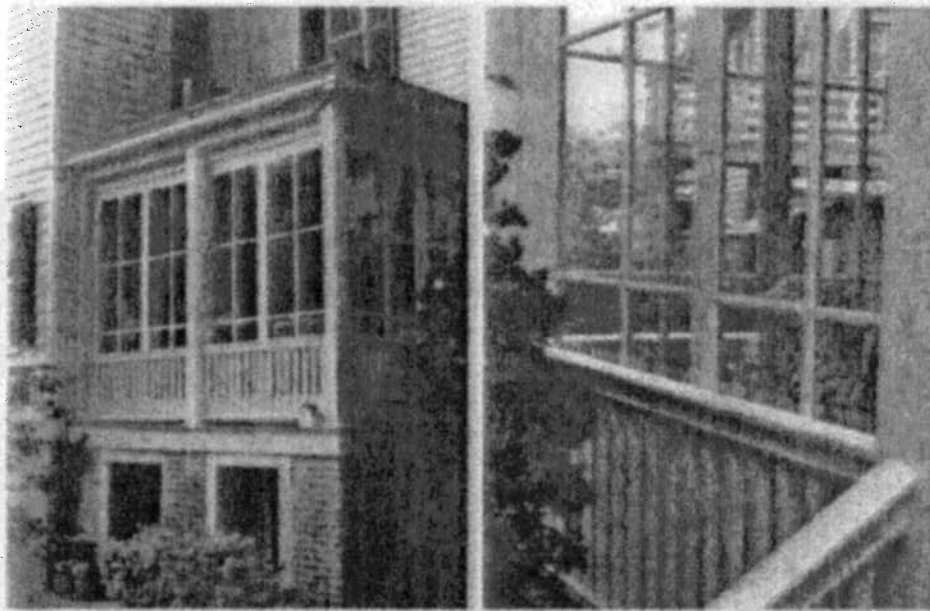
Figure 12. This old porch enclosure, located on the back side of a house, has acquired significance over time and is remarkable both in the appropriateness of its detailing for use by others today, as well as its high degree of maintenance. The enclosure is set behind the columns; the balustrade has been retained; and the light divisions and the size of the glass panes echo that of the windows above. Within each bay there are two well-crafted, inward-swinging doors, providing for greater seasonal use of the porch. Photos: Charles Fisher.

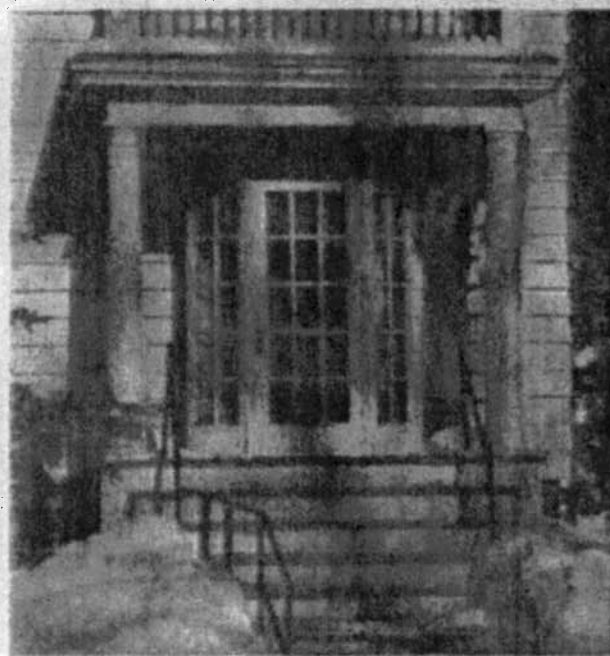
Figure 13. Particularly in New England, there is a cold weather tradition of installing temporary glass and wood panels at entrance doors, thereby creating an enclosed vestibule. These enclosures with their small divided lights were generally removed in the spring. Photo: John Leetz.

months while not permanently altering its appearance. In fact some have become historic features of buildings. Particularly in New England, there is a continuing tradition of installing relatively substantial glass and wood panels on porches during the winter, especially around an entrance door. These tended to have small divided lights. Sometimes porches were fully enclosed with a divided light glass door for entry, creating an enclosed vestibule that reduced the amount of cold air entering the house when the door was opened. Others consisted of simple sidewalls perpendicular to an existing entrance door, serving as a windbreak. Such enclosures were generally removed in the spring (Fig. 13).

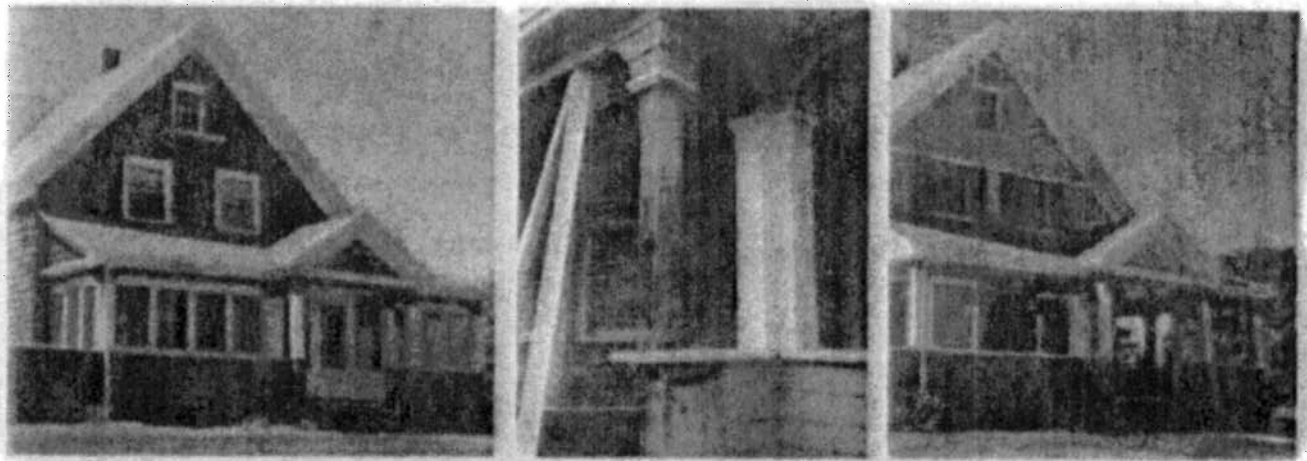
Figure 14. The enclosure of a prominent porch can dramatically change the historic character of a building. The L-shaped porch on this 1896 Shingle-style New England residence was later enclosed with aluminum windows and screens. Recent owners elected to reopen the historic porch. Among the other work, it was necessary to correct structural damage, as with this post, where beneath the wood casing carpenter ants had done serious damage. In reopening the porch, the historic character of the residence has been brought back and the traditional use of the porch is once again enjoyed. Photos: Mark Landry, Landmark Services.

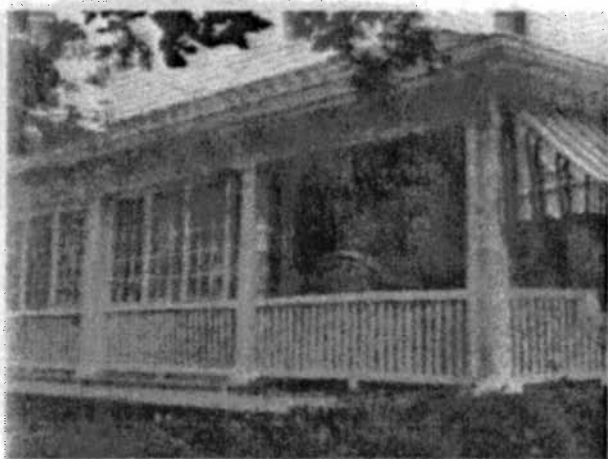
Figure 15. A traditional technique of porch enclosures still used today involves the insertion in each column bay of one or more glass enclosures set in wood frames. This enclosure is properly set back an entire porch bay from the front of the house and utilizes traditional light divisions and wood frames. The balustrade, added here for illustration purposes, shows the importance of retaining this linear feature within the enclosed bays. Photo: Charles Fisher.

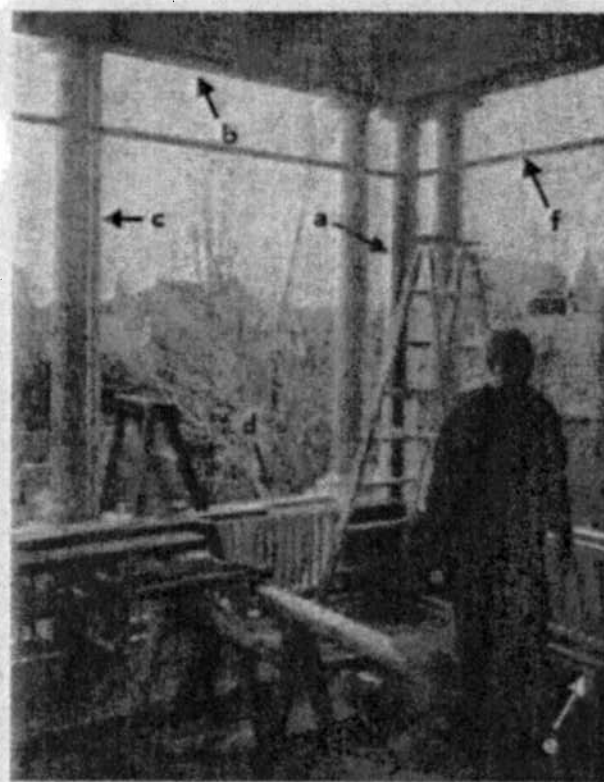
Figure 16. The use of near full glazing to enclose a porch may be appropriate depending upon the historic character of the building, location of the porch, how the interior space is to be treated, and other factors. This enclosure of a rear porch to create a conference room successfully utilizes large expanses of glass and narrow metal framing set behind existing porch elements (a through e). Where an additional horizontal support was needed (f), the frame was placed at a location that is found in many traditional insect screen enclosures. Photo: Charles Fisher.

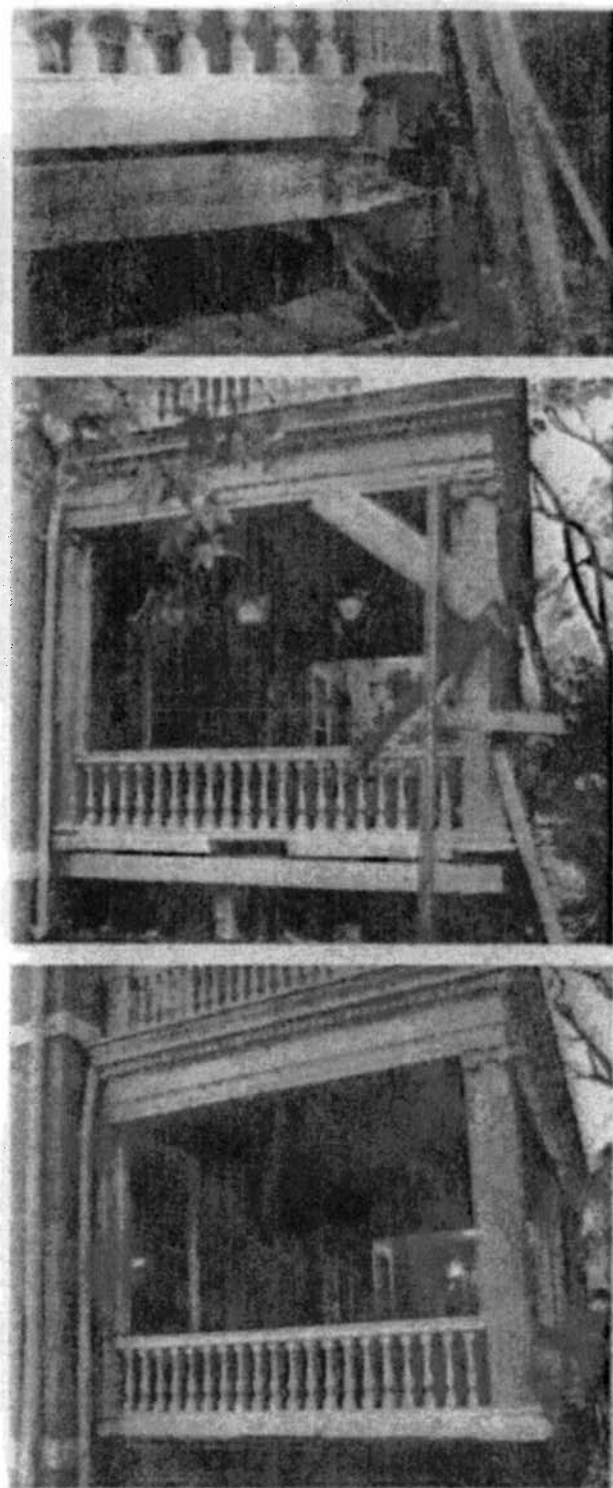
Figure 17. The porch's structural system must be capable of supporting today's loads. In this case moisture led to the deterioration of the wood girder at the corner, creating a major structural deficiency (top). A new solid timber was installed to replace the girder (middle); alternatively a built-up girder could have been used since a fascia board would conceal it. The column base was repaired and portions replaced and the balustrade and column reset and secured (bottom). Photos: Paul Marlowe, Marlowe Restorations.

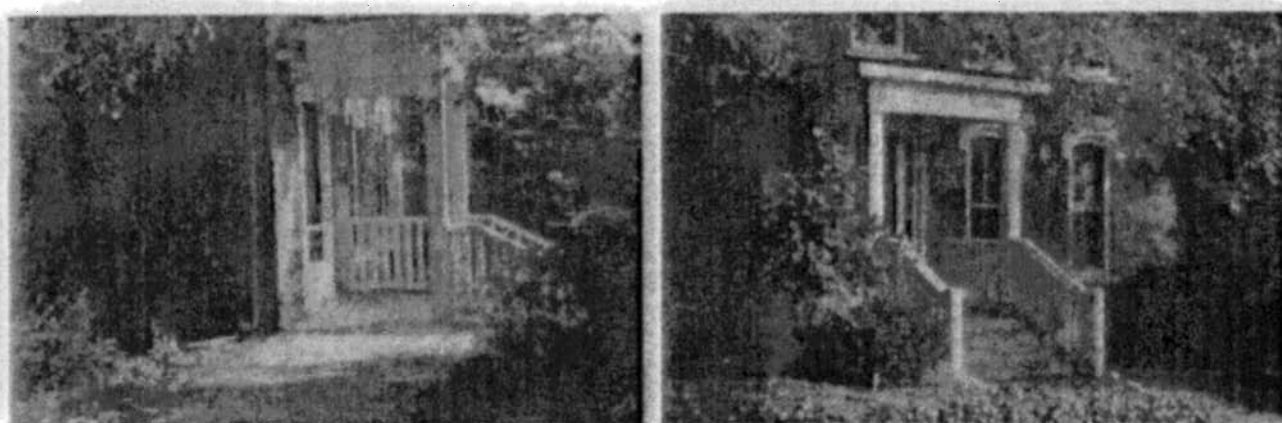
Figure 18. When a porch is used as a wheelchair accessible entrance, it may be possible to retain the historic stairs by adding a ramp parallel to the building. Through plantings and some re-grading, the new ramp built parallel to the building (left) allows retention of the historic stairs and does not impact the historic character of the entrance (right). Photo: Iowa State University Extension.

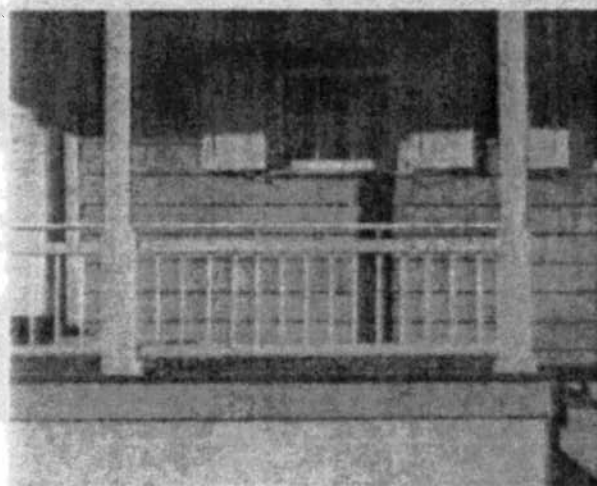
Figure 19. Historic porches generally have railings that measure 28 to 30 inches in height from the floor. When additional height is necessary for safety, a simple rail, added for illustration purposes in this photograph, can usually be installed above the historic railing. Not only does this treatment allow retention of the historic balustrade, but it also has a minimum impact to the appearance of the porch. Photo: Charles Fisher.
